Manhole Inspection Summary

Manhole # S31CC_057MH

Insp Date: **2/6/07 10:26 AM**

Location Address: **EUTAW ST**

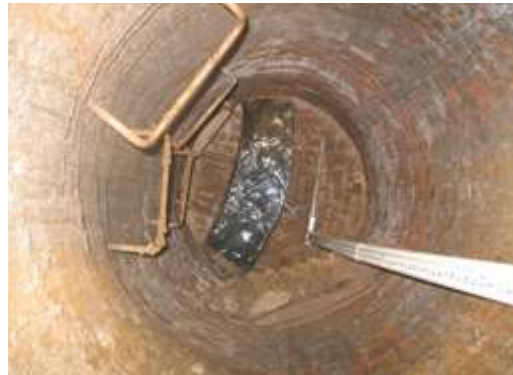
Top View

Bench debris.

Unknown pipe

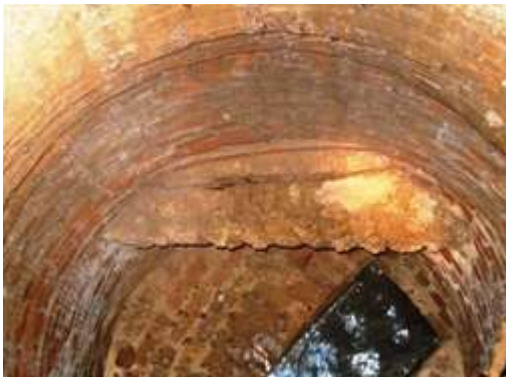
Defect

Adjustment, Corbel and Barrel infiltration.

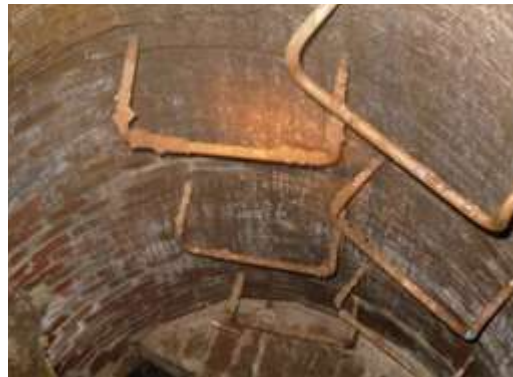
Defect

Frame leaks. Adjustment infiltration.

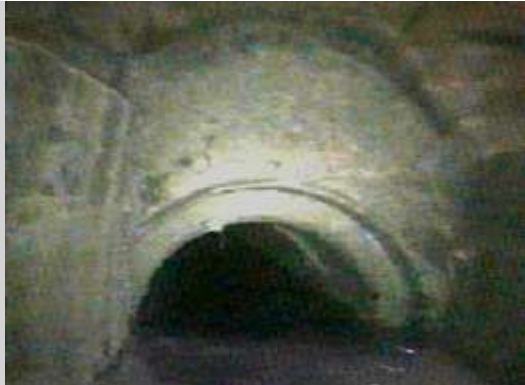
12 in. Circular Gravity Sewer Pipe Out @ 12 O'Clock

Infiltration: **Evidence** Pipe Seal Cond: **Unknown**

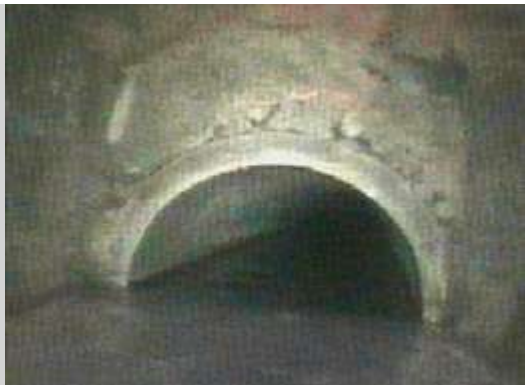
12 in. Circular Gravity Sewer Pipe In @ 7 O'Clock

Infiltration: **Evidence** Pipe Seal Cond: **Cracked**
